FOG Investigations

Bob Bowren

Timeline of Events

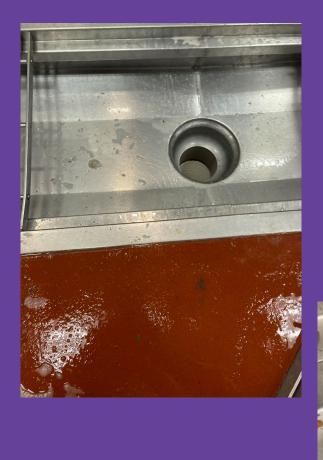
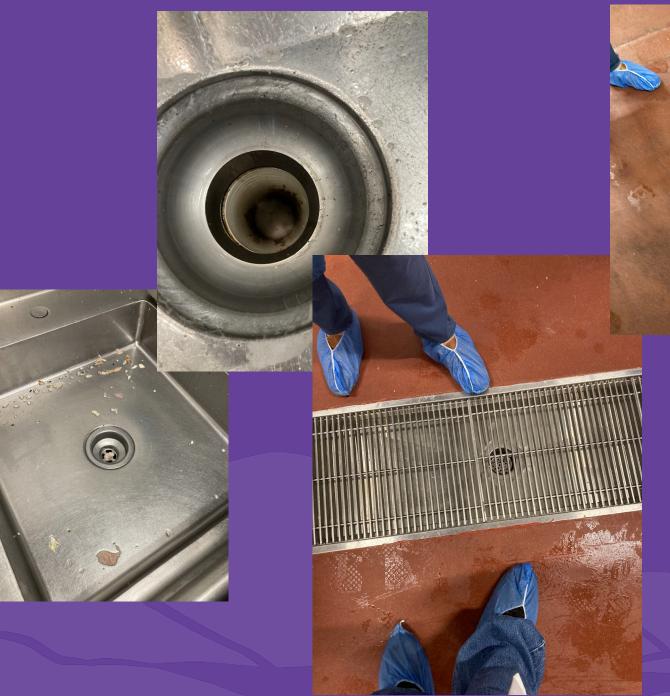
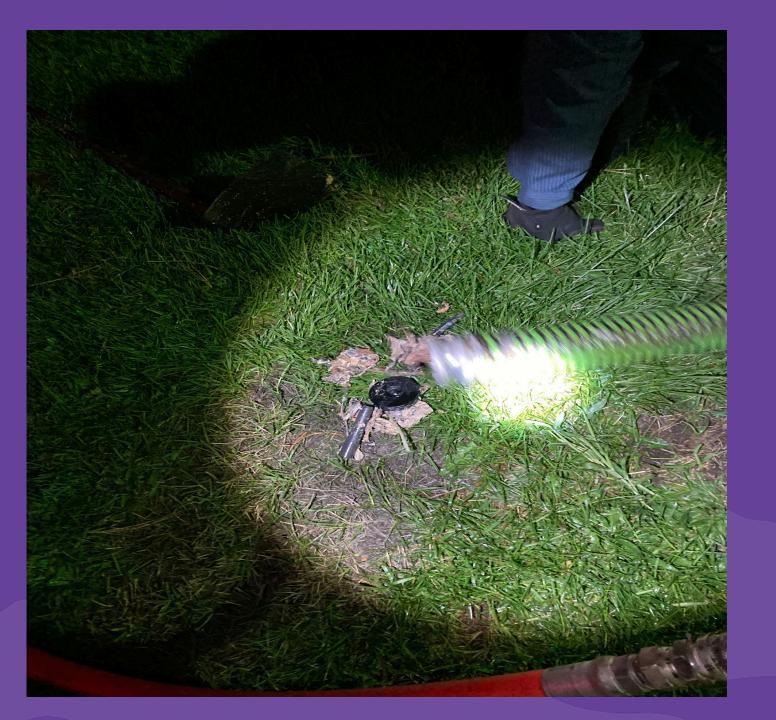
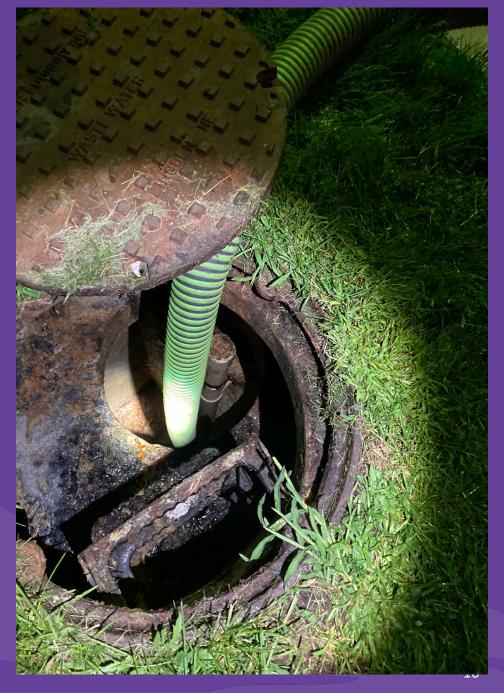
A second IPT inspection of the facility occurred in August 2022 where it was noted that just about all the drains had their internal screens removed at some time since installation. IPT conducted several inspections of the weekly service to the interceptor which were occurring at 4:00AM and found large amounts of meat solids withing the interceptor with even chunks of metal that had been washed down during the cleaning operations and were not contained due to lack of screens.

A second Notice of Violation was issued to have all the drain fixture screens replaced which was accomplished within two weeks.

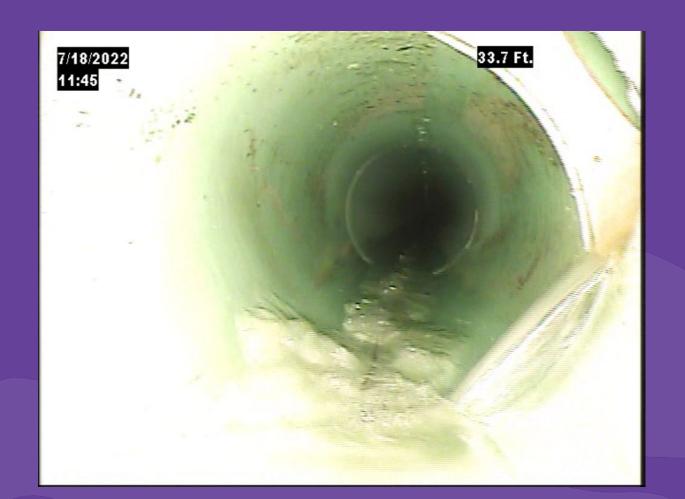
If I could have found a fat burg this would have been very easy to enforce.

We looked almost two miles downstream.
