FOG Investigations

Bob Bowren

Timeline of Events

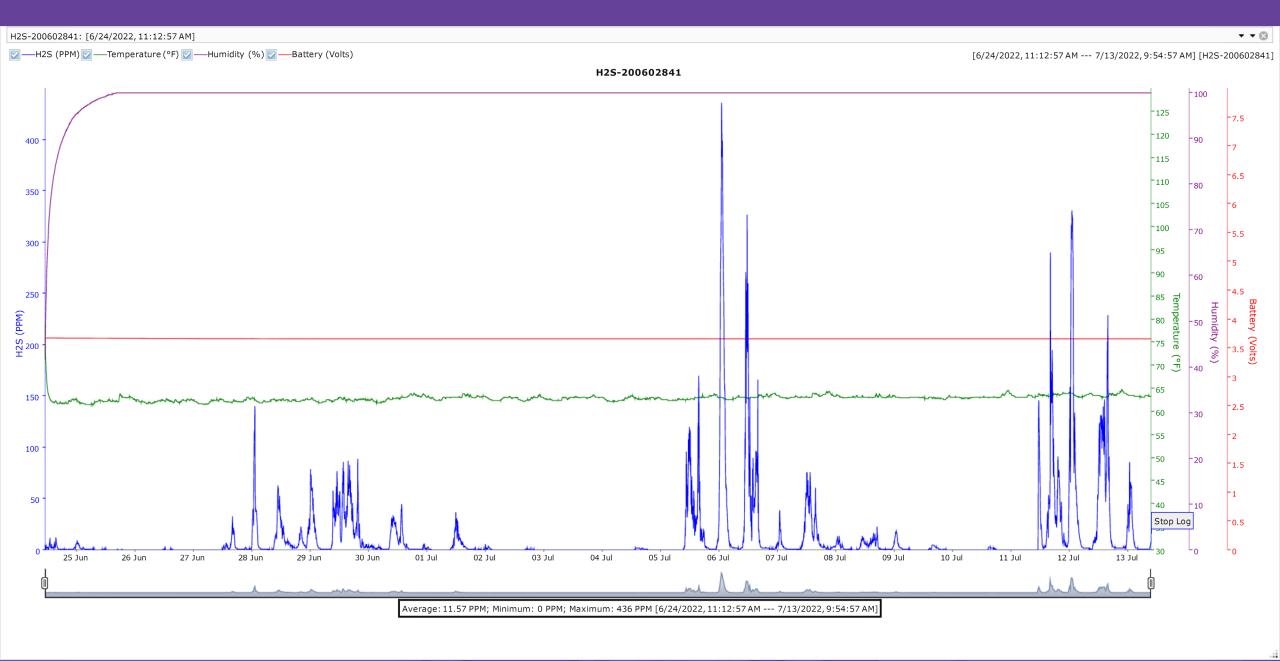
Reports of odor in the area and inside several businesses starting in 2017.

Utilities Wastewater Engineering staff began evaluation of main line using OdaLog instruments and found higher then usual H2S readings and a noticeable aboveground odor at times during the year.

A section of the main service line was found to be sagging causing a low spot allowing accumulation of gasses.

Utilities Engineering also visited the businesses in the area and identified plumbing defects and unused drains using smoke tests that were allowing odor to infiltrate buildings.

But the higher level of H2S remained in the line.

Utilities performed repairs to the main wastewater line over the next several years to attempt to improve the situation.

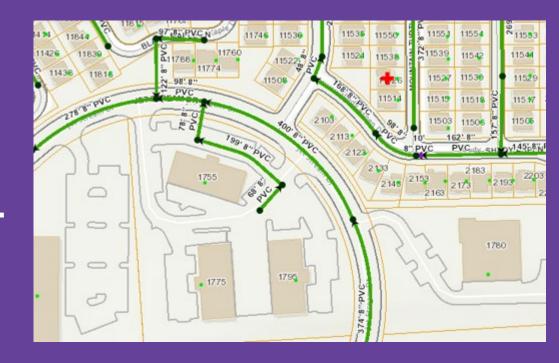
Using OdaLog data and GIS, pretreatment was able to identify an upstream business as a likely source however no indication in the billing indicating a business that would likely produce the waste stream.

However, the identified business had been started under an account the owners previously used for a religious literature warehouse operation. It never showed up in the billing account as a meat roasting and smoking operation.

Pretreatment Specialists inspected the business in June of 2022 (the FOG guy was out on vacation). Finding the type of operation within, a Verbal Notice of Violation was issued requiring the business to take steps to reduce the H2S entering the POTW and submit an industrial survey.

The business, who was and has remained very cooperative immediately began servicing their 5000-gallon interceptor weekly in and attempt to control the formulation of H2S gasses in addition to adding a chemical auto feeding "binder" to control the release of the gas.
