SOUTH PLATTE  
**RENEW**

# CIPP and your Treatment Plant

# Oxford Stormwater Project

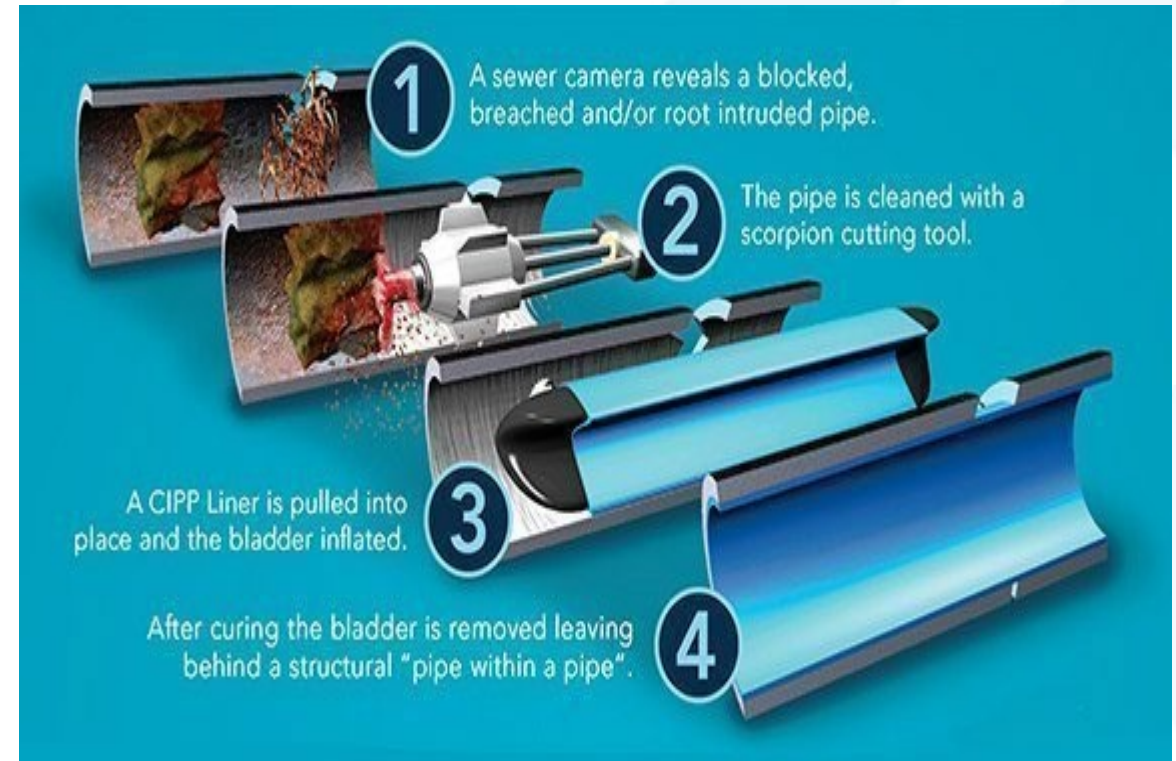
- Cure-in-place Pipe
- “Pipe within a Pipe”
- Used across the country for wastewater, stormwater, and some drinking water applications.
- Process is to insert a felt liner into the pipe that has been saturated with an epoxy, usually styrene based. The pipe is then inflated with hot water, steam, or air pressure and then cured one of 3 ways:
  - Hot water- 180- 190 °F
  - Steam
  - UV Light
